Technical Solution for Mitigating Radio-Frequency (RF) Interference to Air Traffic Control Communications

ARL-TR-6596

September 2013

Robert L. Atkinson
Sensors and Electron Devices Directorate, ARL

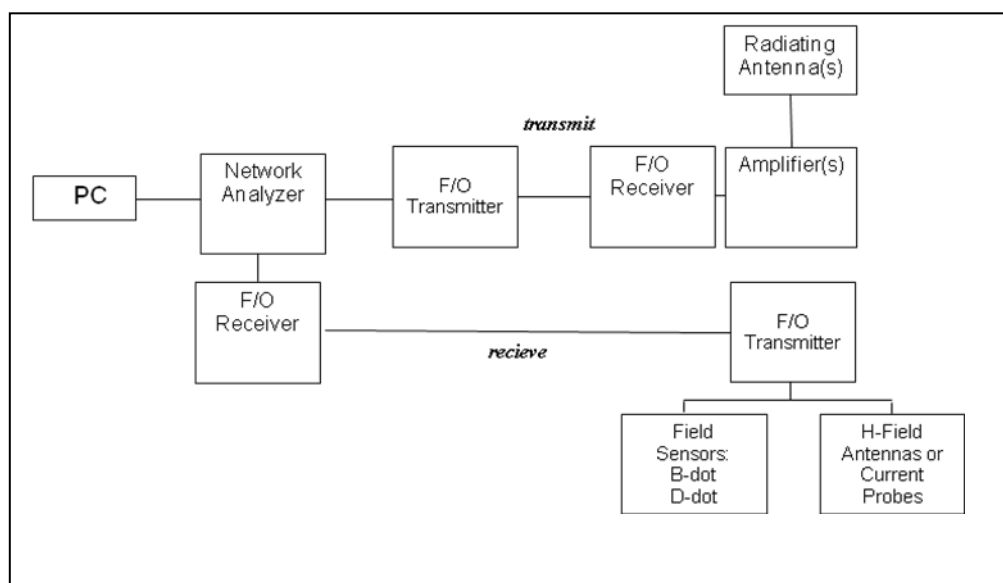
Figure 1. Functional CWI test equipment setup.

The fiber-optic data systems in use by ARL, which are shown on both the RF source transmit portion of the setup as well as the data receive portion of the setup, possess the high technical qualities needed for the CWI measurements. During the deliberations held in late November, it was determined that the interference problem was being created by the fiber-optic system on the transmit portion of the test setup. It was subsequently discovered that broadband RF noise can be emitted, under certain conditions, by the fiber-optic receiver. Such conditions can occur for a variety of reasons including: (1) lack of coherent signal input to the fiber-optic transmitter, (2) power to the fiber-optic receiver being turned off, and (3) loose or degraded fiber-optic cables that connect the fiber-optic transmitter to the fiber-optic receiver.

The source of the broadband noise is the automatic gain control (AGC) circuit that is within the fiber-optic receiver. When coherent signals are present at the input to the transmitter, the output of the AGC is at a minimum level, which is on the order of -10 dB. This is its normal operating state. However, when one of the three previously identified conditions arise, the AGC will increase its output as it searches for a coherent, incoming signal from the transmitter.

If no such signal exists, the AGC output state increases to its maximum, which is about 40 dB above normal. Since the output of the AGC is reflected directly at the output of the fiber-optic receiver and, if the RF amplifier is turned on, the result is to send the AGC output to the radiating antenna. When amplified and transmitted, this broadband noise would disrupt the air traffic control communications. Since such systems are used throughout the Government and by its contractors for various RF testing configurations, a technical “fix” (or fixes) would need to be devised to eliminate any future occurrences, if possible.

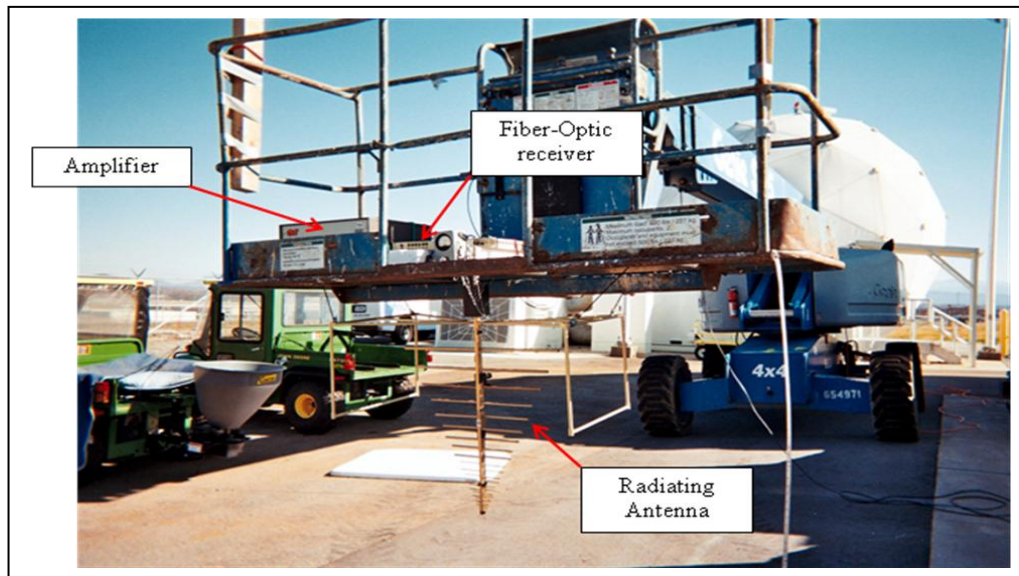
Figure 2. Fiber-optic receiver and amplifier in lift-bucket.

Typically, the network analyzer and fiber-optic transmitter are co-located. If a RF shielded room is available, both instruments would reside inside the shielded area. The fiber-optic receiver and amplifier are also co-located. More often than not, they reside outside of the shielded area and relatively close to the radiating antenna. As an example, figure 2 shows a typical setup configuration for the transmit portion of the test setup.

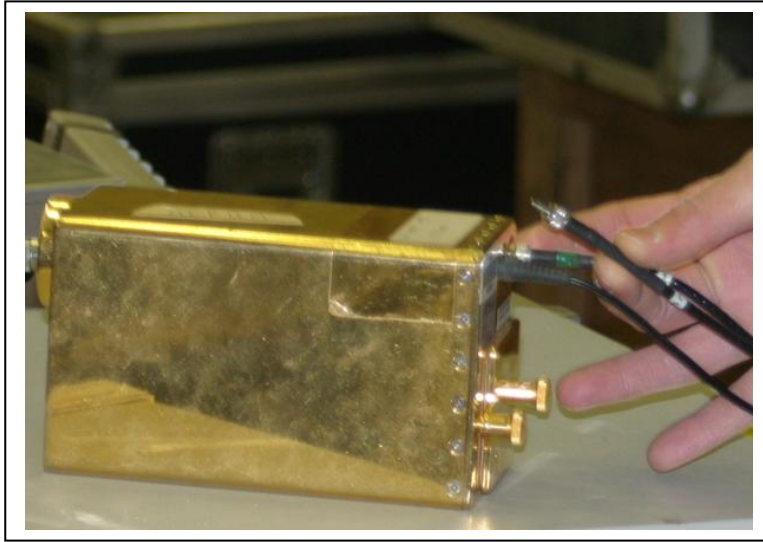
Figure 3. Transmitter with cable removed.

Understandably, the initial deliberations all focused on changes to the SOP. These included the administrative (i.e., procedural) controls all ready in use. On 15 November 2012, it was discovered that the interference conditions were initiated by loosening and removing either of the two fiber-optic data lines on the rear of the fiber-optic transmitter, as shown in figure 3. Such was being repeatedly performed during the tests in order to preserve the transmitter's battery life or move the transmitter from one terminal to another.

One solution, requiring only minor modifications to the existing SOP, would have been to simply disable the amplifier prior to removing a fiber-optic cable from the transmitter. Unfortunately, that process could not account for any unforeseen failures in fiber-optic data system during the normal test process, such as an accidentally loosened or broken fiber-optic cable. Further, disabling the amplifier would have meant de-energizing the circuit that fed electrical power to the lift bucket. Just “pulling the plug” would have cut the power to the amplifier, as well as the fiber-optic receiver. When electrical power was restored by reinserting the plug, there could be no guarantee that all of the relays within the fiber-optic transmitter would successfully reset, thus causing a high-AGC condition. Finally, the solution does not account for human error. As a result, it was determined that merely updating the test process controls would yield an insufficient solution.

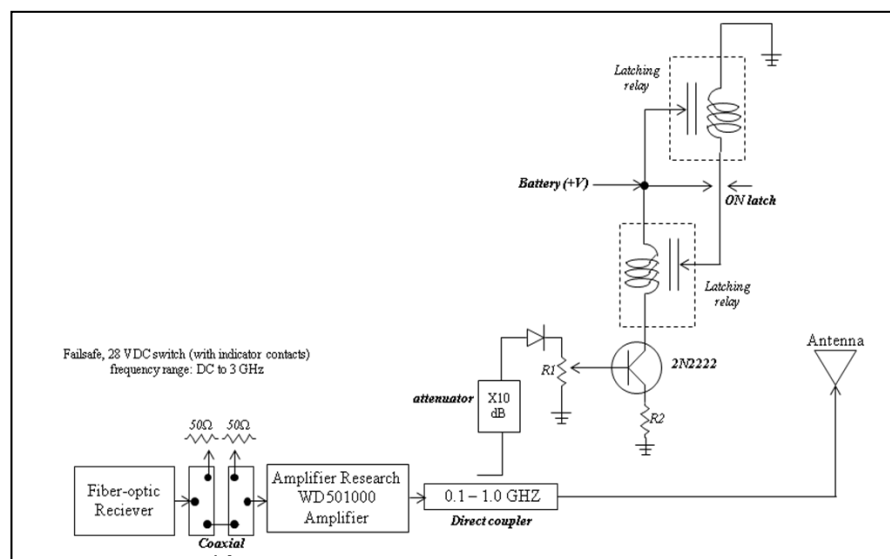
Figure 4. Partial solution—switches, relays, and couplers.

Another potential solution considered the use of two coaxial switches, a directional coupler, and latching relays to control the amplifier output. The coaxial switches would be placed between the output of the fiber-optic receiver and the input to the amplifier. The latching relays and directional coupler, placed on the output of the amplifier, could serve to redirect any unintentional, broadband output from the radiating antenna to a non-radiating 50-ohm “load.”

A series of “bench tests” would be needed to test and finalize the initial design (figure 4). Estimated electronic component costs were on the same order of magnitude as the software solution. Although the minimum man-hour labor load was expected to be only about a month, the inability to quickly verify a “final” circuit design represented the highest risk.
